Interstate 5 – South Bound
KP 0.0 to KP 2.7

DOWEL BAR RETROFIT EVALUATION

DISTRICT 12
Orange County
Interstate 5

Contract Number: 12-093904

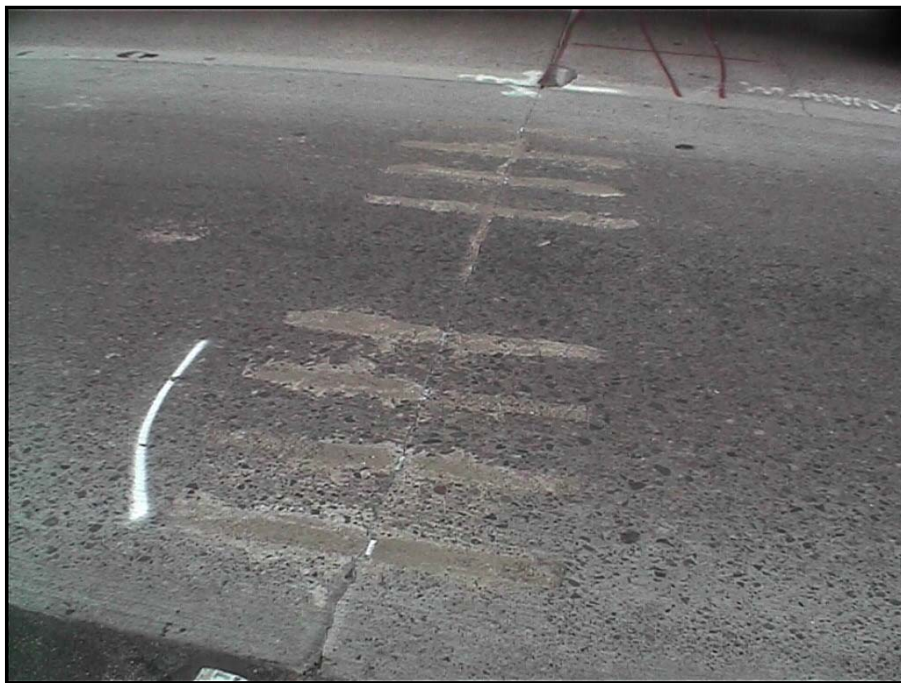
Figure 5. Dowel Bar Retrofit Installation

The pavement inspection was performed on Tuesday, October 2, 2001. Upon arriving at the project site, the ride over the dowel bar retrofit installations was found to be rough. Several panels along the retrofitted segment from the El Camino Real Under crossing to the Mendocino Over crossing in lane 4 were examined. Core samples were taken at various locations to evaluate the backfill grout and replacement concrete. The installations appeared messy due to the abundance/overflow of backfill grout in and around the slots. Traffic loading has begun to break off the excess grout. A total of 4 dowels per wheel path were installed at the transverse joints, as required.

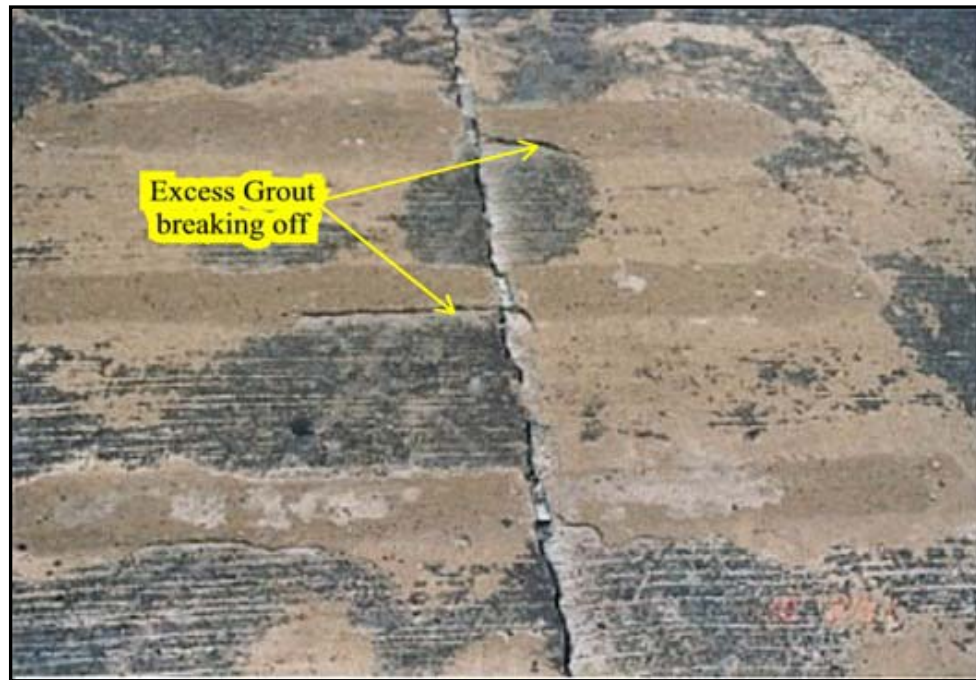
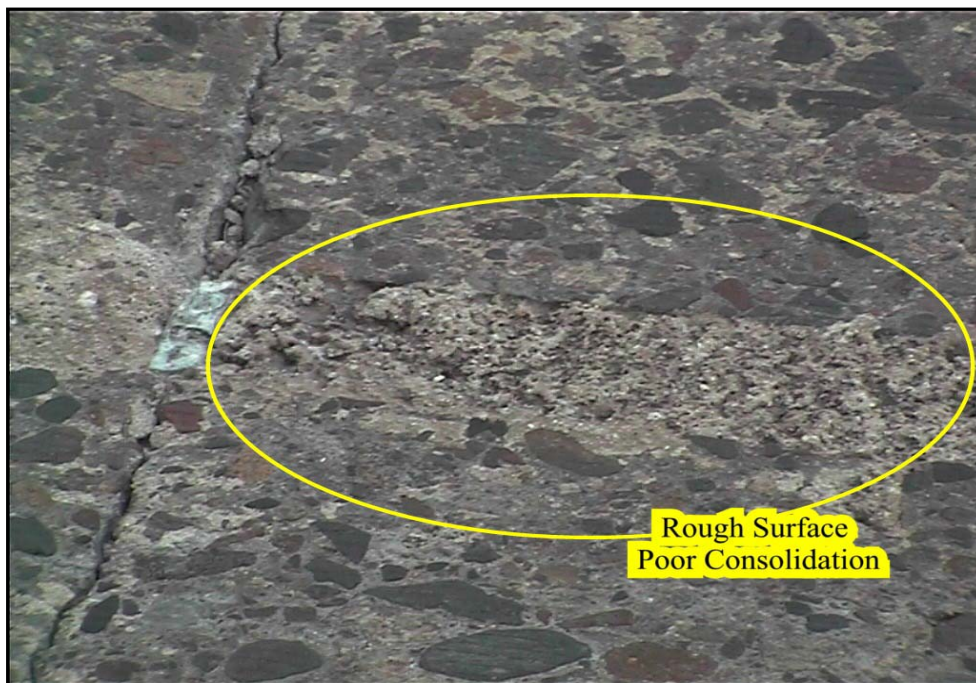
Figure 6. Backfill Grout

The backfill grout in some of the slots observed was between 5 mm and 10 mm above the pavement surface. The project special provisions require that the fast setting backfill grout be finished 3 ± 1 mm above the existing pavement. Some slots had a rough finish, showing poor consolidation and other flaws at the surface (Figure 6).

The intermittent rough finishes are evidence that at times the grout was ‘over-aged’ or allowed to stiffen before placing was complete. It appears that too many dowel bar slots are being backfilled from a single batch of the fast setting grout.

“Fast setting grout shall be mixed in accordance with the manufacturer's instructions.” It is imperative that the contractor and inspectors be aware that the available working time of the fast setting grout is limited. Grout batches should be sized so that the entire batch can be used, placed, and consolidated within the allowable working time. Any material that cannot be placed and consolidated within that time should be discarded and properly disposed of.

“The grout shall be vibrated with a hand held vibrator capable of thoroughly consolidating the grout material into the slot and around the dowel bar support chairs.” If the grout cannot be placed and vibrated without disturbing the dowel, an external downward force should be applied to the dowel during that operation.

The surface of backfilled dowel bar slots should be rounded 3 ± 1 mm above the existing concrete surface as specified. Grout finishing that does not conform should be immediately rejected. Specifications for future projects should require that backfill material exceeding this

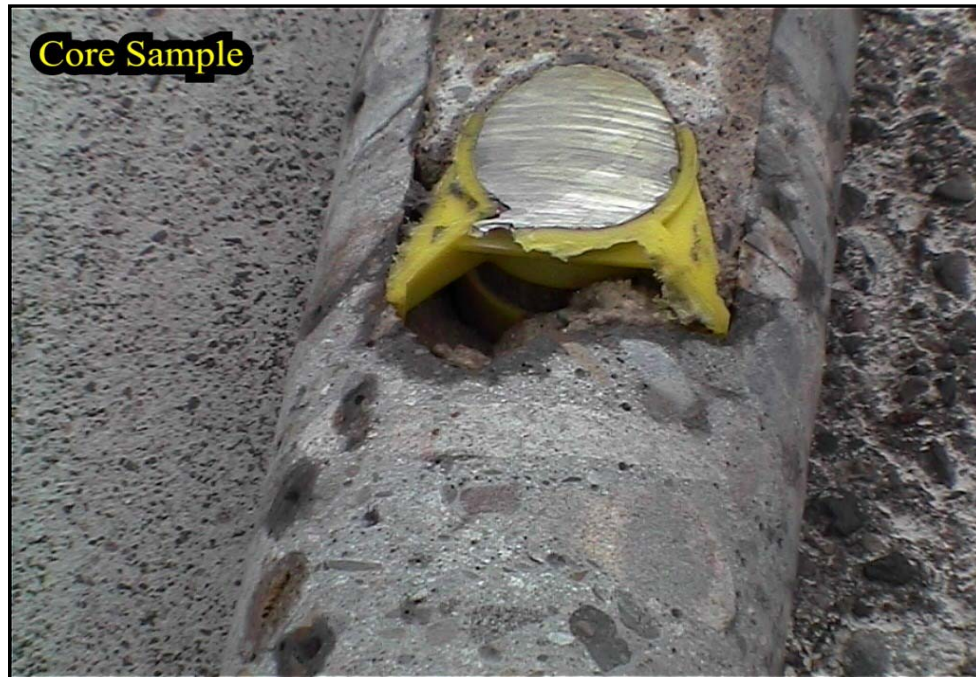
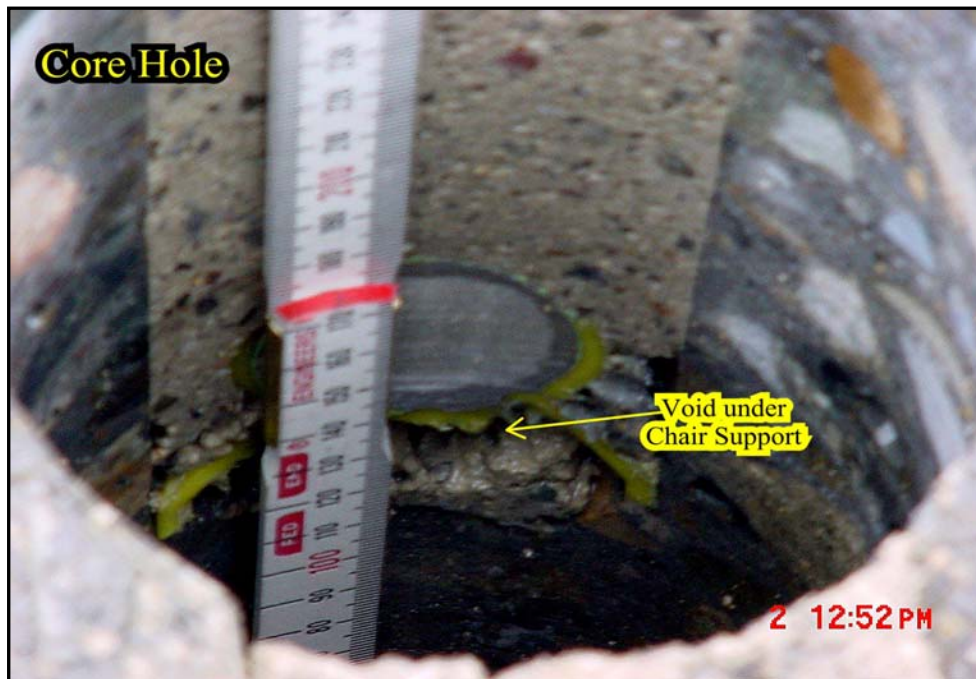
Figure 7. Void under Dowel Bar Support

Three cores were taken at retrofit slots. The cores showed that the top of the dowel bars were at 112, 113, and 109 mm below the surface. The top of the dowel bars should be at 118.5 ± 6 mm below the surface. The grout in the retrofit slots was fairly well consolidated and predominantly free of voids. In the second core sample, mentioned above, there was a significant void under the dowel bar chair supports indicating that the backfill grout failed to fill the slot entirely (Figure 7). In the third core the support chair was not resting on the bottom of the slot indicating that the dowel was either moved during back filling or not properly placed.

The dowel bars seem to be being disturbed during grout placement.

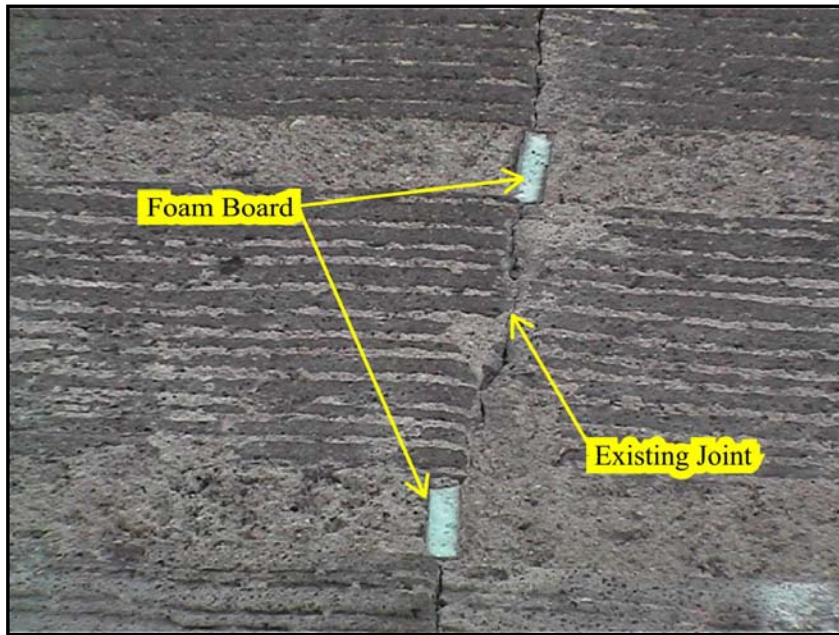
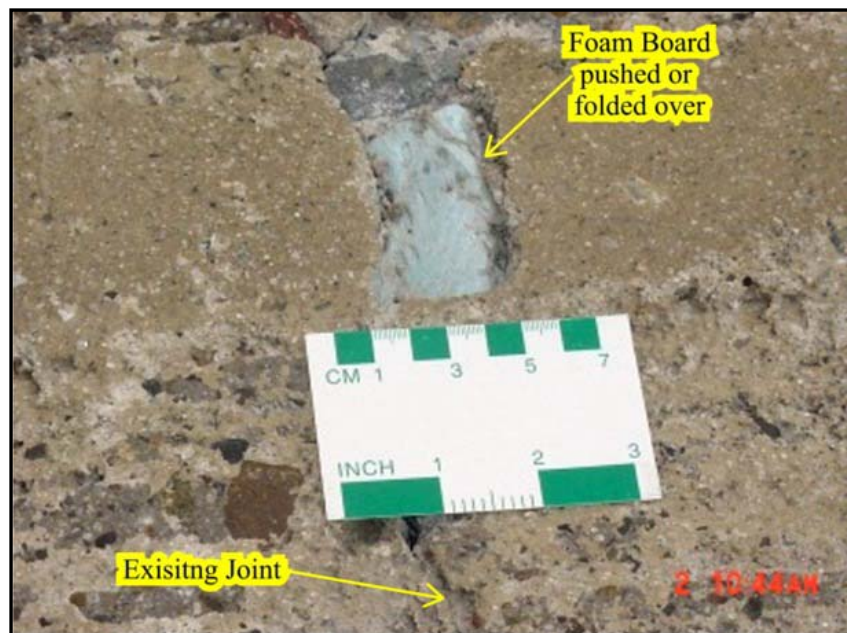
Figure 8. Foam Board Alignment

Many of the foam boards were aligned with the existing transverse joint. The foam boards are approximately 12-mm thick and seem to be adequate for maintaining the existing joint. Occasionally, the foam board was pushed or folded over at the surface; this may indicate that the dowel is not at the correct depth.

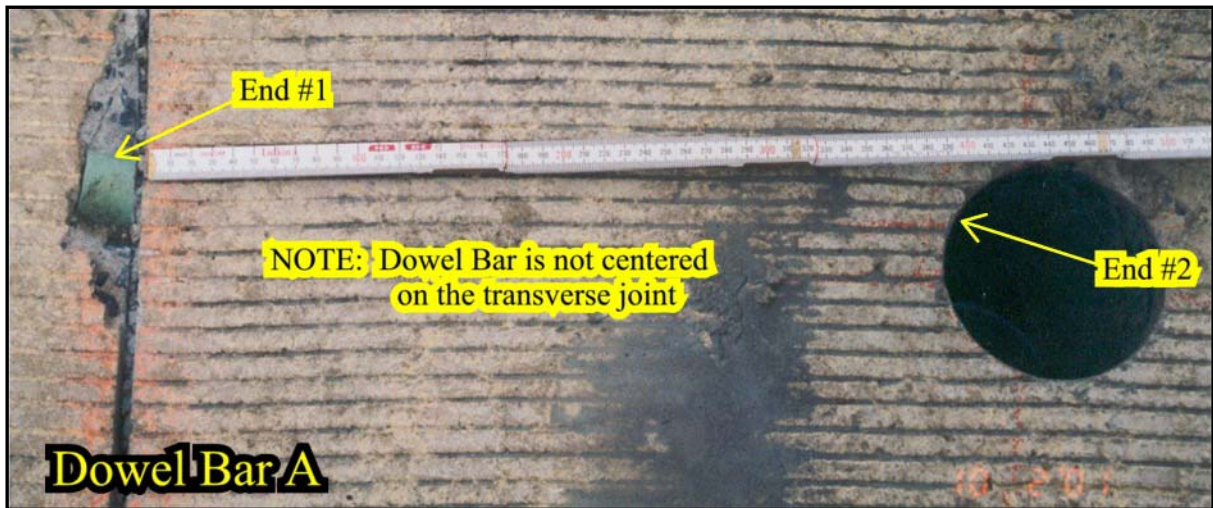
Figure 9. Dowel Bar A

Slab replacements were also examined. The contractor installed dowel bars in the replaced slabs by using dowel bar assemblies (baskets). While inspecting the replaced slabs, a total of three dowel bar ends were discovered at the surface near the joints in two different slabs.

Two of the dowel bars were further examined by coring. At the first dowel bar, the embedded end was cored and found to be 140-mm below the pavement surface (Figures 9 and 10).

The alignment of the dowel bars and/or assemblies in the replaced slabs appear to have been displaced during the concrete placement operation. The resident engineer or inspectors should have information in their records as to how this may have occurred.

Pursuant to Section 6-1.04 of the Standard Specifications (1999), "DEFECTIVE MATERIALS," the Engineer should direct the Contractor to remove and replace the concrete pavement, and associated work, that does not conform to the requirements of the plans and specifications. Due to the lack in workmanship, it is necessary and appropriate to require that the Contractor determine the extent of non-compliant dowel bar assemblies by coring at each transverse joint. The Engineer should witness the coring operation and decide whether the dowel bar assembly complies with the requirements of the plans and specifications. The costs for all work required for identifying the extent of compliance or non-compliance; removal and replacement of non-compliant concrete pavement; and placing of backfill at cored locations of compliant concrete pavement should be borne by the Contractor.

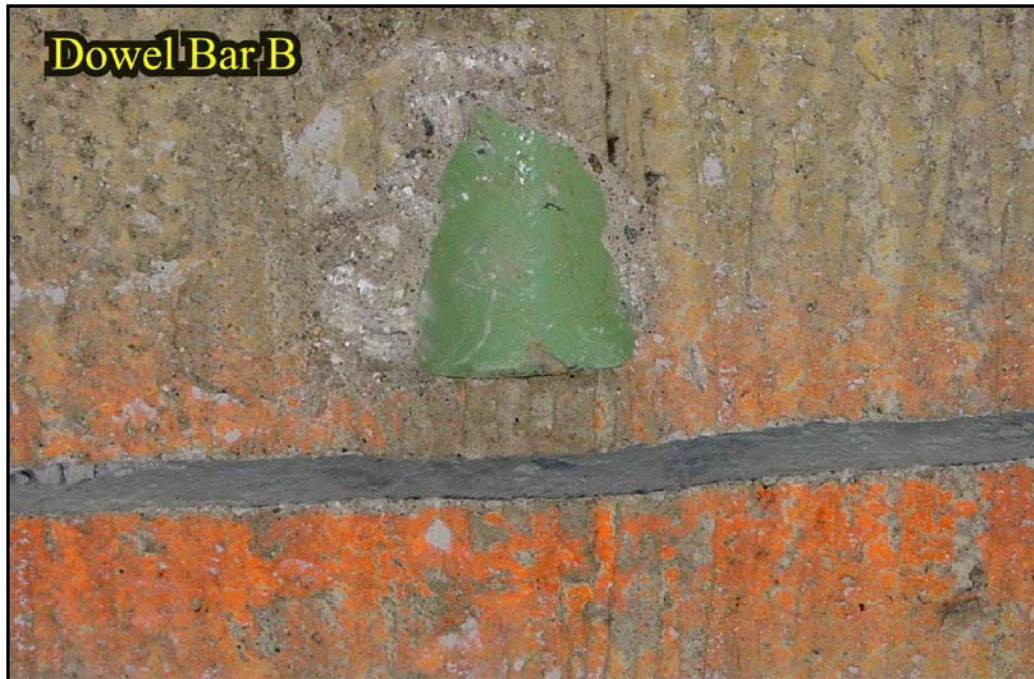
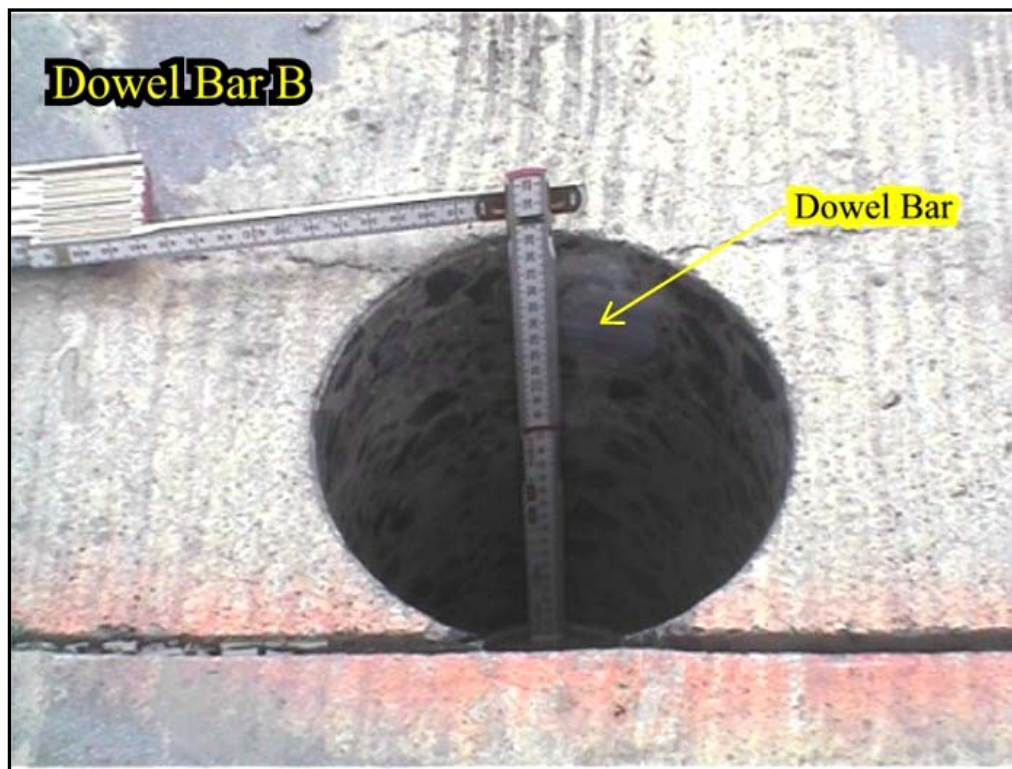
Figure 11. Dowel Bar B

At the second dowel bar, a 150-mm core was taken at the exposed end in an attempt to capture part of the dowel bar support assembly (Figure 11). The assembly was not captured.
